PISCATAQUA RIVER BASIN
FARMINGTON, NEW HAMPSHIRE

BERRY BROOK DAM
NH 00313

PHASE I INSPECTION REPORT
NATIONAL DAM INSPECTION PROGRAM

DECEMBER 1979

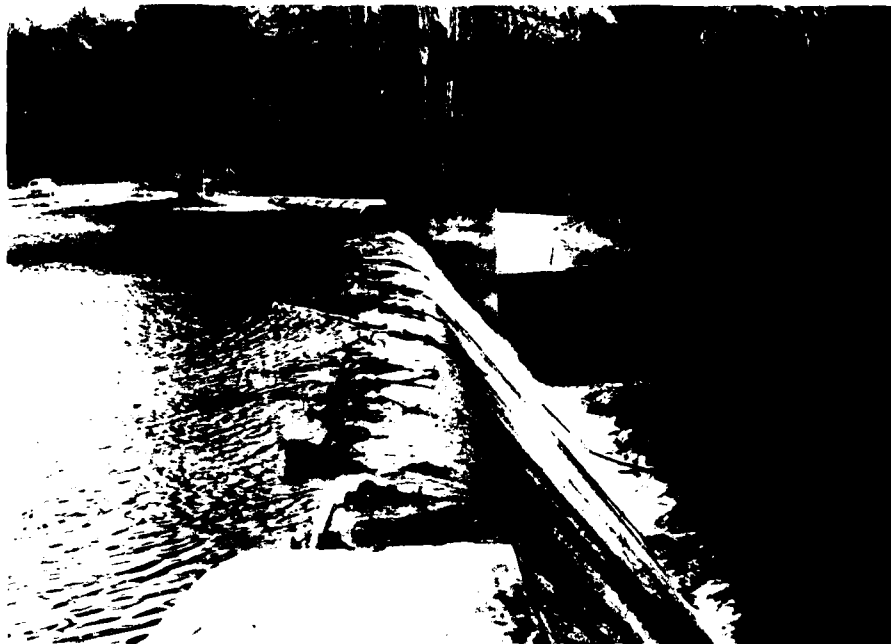
October 25, 1979
 Figure 2 - Looking east along spillway crest from west abutment. Note large pine tree growing in earthfill near east abutment.

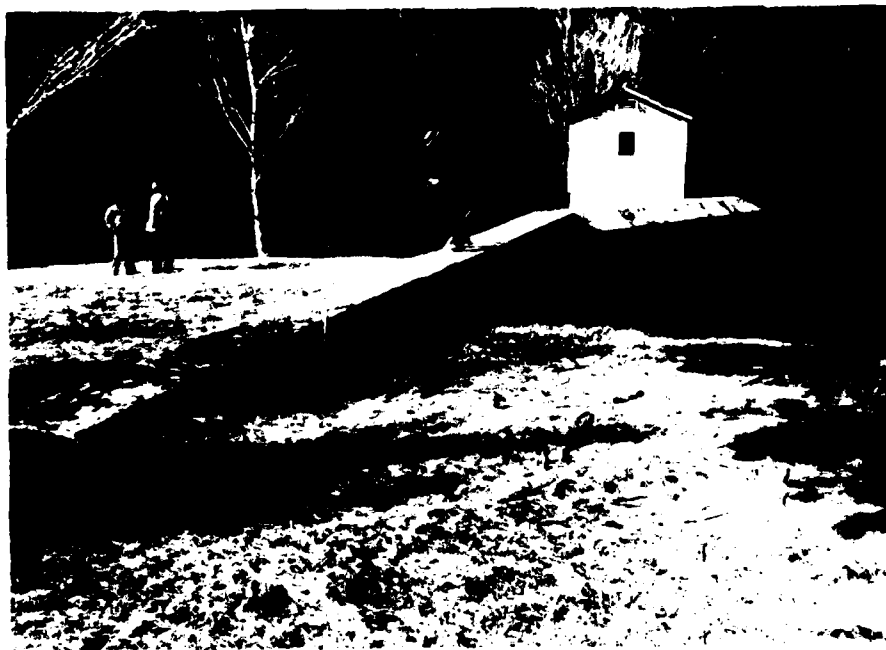
October 25, 1979
 Figure 3 - Looking at the east abutment of the dam.

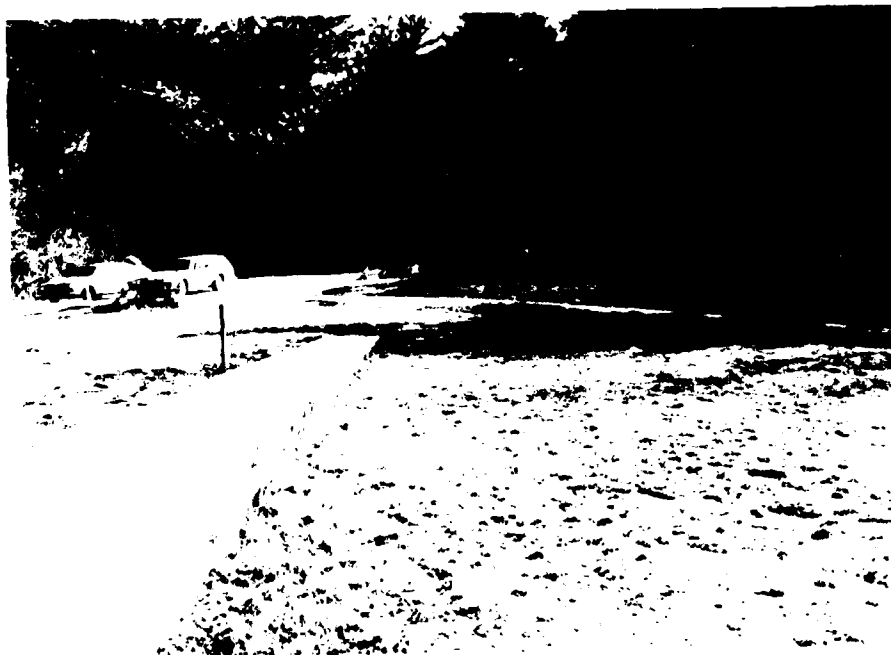
October 25, 1979
 Figure 5 - Looking at the east end of the dam. Note gravel roadway.
